# Evaluating roughness of logging haul roads within the Monongahela National Forest

West Virginia University  
Agricultural and Forestry Experiment Station

Bulletin 677T  
August 1982

Michael R. Sprouse, Kenneth L. Carvell,  
Penn A. Peters, and Gary D. Falk

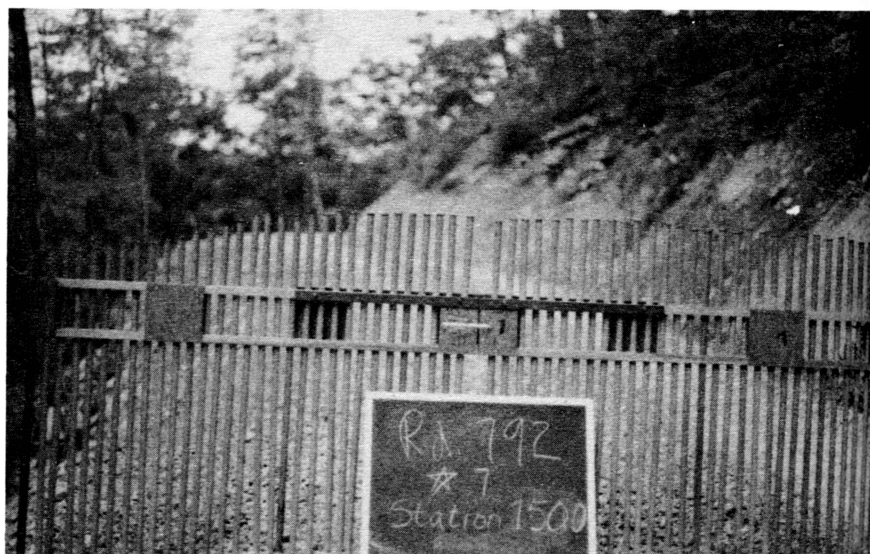
A special piece of field equipment was constructed to aid in measuring the roughness of the road surface (Figure 1). This "dowel jig" consisted of 62 wooden dowels, 3 feet long, which passed through holes bored 1.5 inches apart through an 8-foot crosspiece constructed of wood.

Figure 1. Dowel jig used for measuring the roughness of the road surface.

At the beginning of the data collection period, an attempt was made to utilize a 16-foot section of dowel jig. The dowel jig was attached to the back of the truck and was raised and lowered by a set of pulleys and cables. The 16-foot section consisted of four 4-foot sections connected by hinges. Use of this apparatus was discontinued due to the difficulties involved with raising and lowering the apparatus. The 8-foot section which was carried by two crew members was more efficient and could be moved out of the way of traffic with less difficulty. At each cross section the dowel jig was placed perpendicular to the road with one end at the road margin on the fill slope side. A level bolted to the crosspiece of the dowel jig provided a means of leveling the crosspiece. The tops of the dowels defined the configuration of the road surface. After a

photograph was taken, the dowel jig was moved so that the end that had been at the road margin was at the point where the far end of the jig reached previously, and another photograph was taken.

If a ditch was reached and less than 8 feet of road cross section remained, then a dowel, painted black, was placed in the jig at the point to which the last dowel jig setting reached to avoid adding the overlap to the width of the road. The black dowel contrasted with the other dowels which were painted orange. For this final photograph of the road cross section, a black dowel was placed at the edge of the road so that road width could be easily determined from the photographs. Since the photographs included profile of the ditch, data on the volume of water that a ditch is able to handle was made available. This process was repeated at each 150-foot cross section.

Reduction of the dowel jig data involved projecting the negatives of the photographs for a given road cross section onto the screen of a digitizer. The top of each dowel was digitized and entered into data storage in a desk top computer. A regression line was run through the points. The sum of squares of the deviations of the points from the regression line was obtained and divided by the number of points. The square root of this value was defined as the roughness of a particular road cross section.
